Maintenance & Inspection Division

March 2018 Update

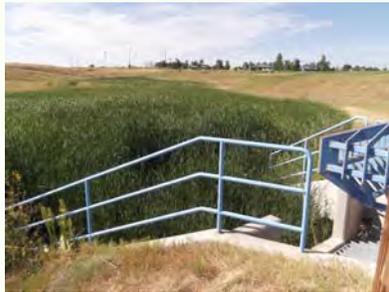
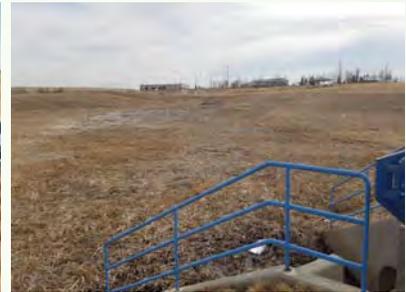
Vegetation Removal

Coordinated with CIP on Russian Olive Removal on Cherry Creek Reach 2

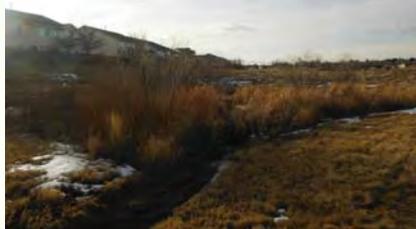
Before

Reservoir Pond (Pond 1)

Vegetation removal

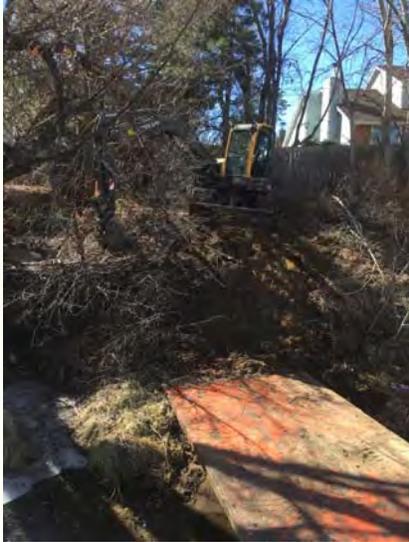
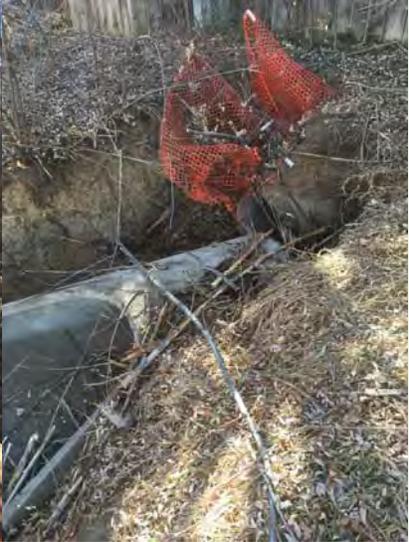
Before Big Dry Creek @ Dry Creek Rd. Outfall Repair

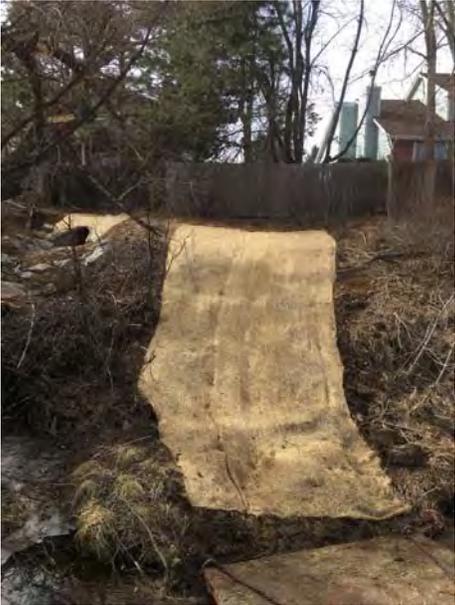
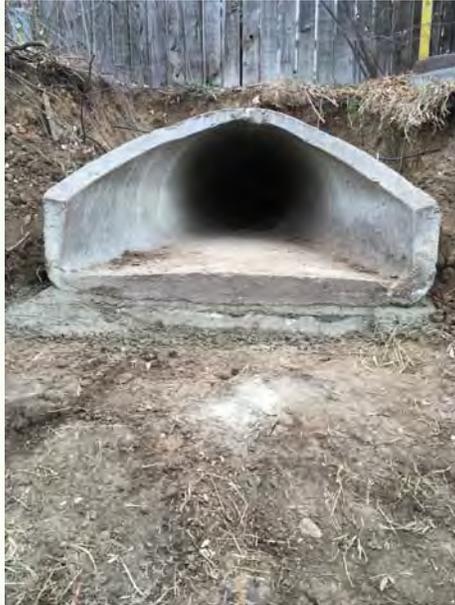
After Big Dry Creek @ Dry Creek Rd. Outfall Repair

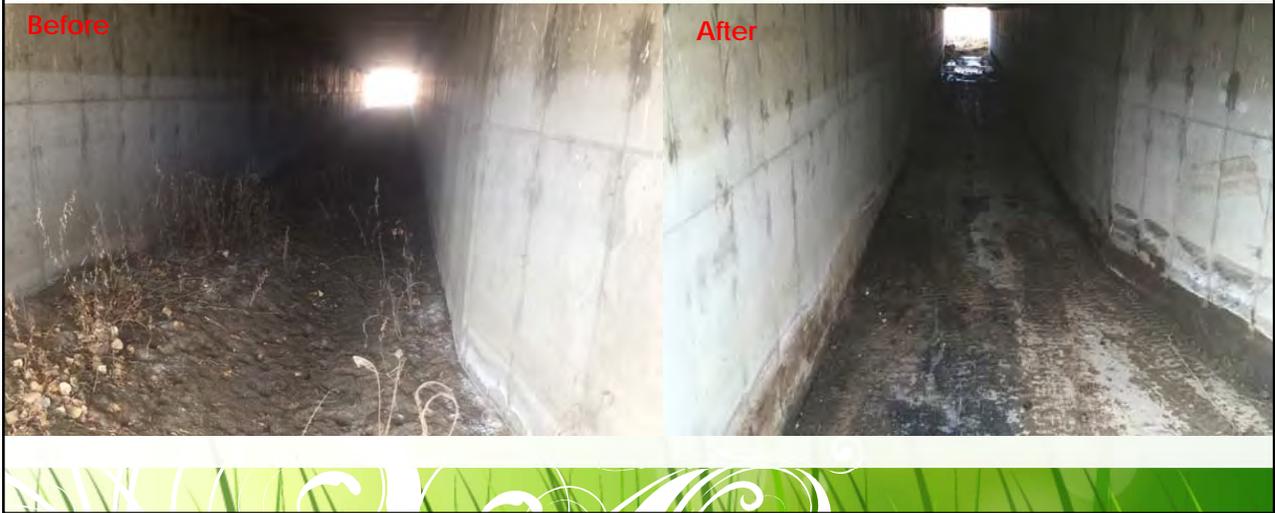
Cottonwood Creek @ Brairwood

Sediment Removal
