Engineering and Construction Division

SEMSWA's Pipe Rehabilitation Program

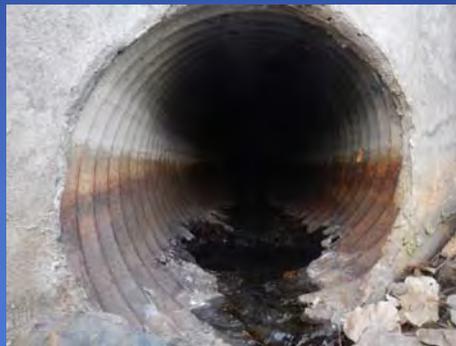
Corrugated Metal Pipe (CMP):
CMP deteriorates, corrodes, rusts
and disintegrates overtime
especially along the bottom of the
pipe.

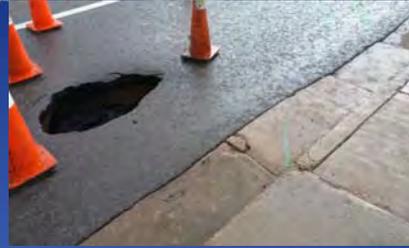
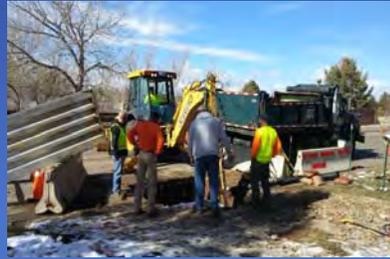
Once pipe invert is compromised water infiltrates and can erode the pipe bedding and soils around the pipe, potentially causing sink holes, compromising safety, roads, and other infrastructure both public and private.

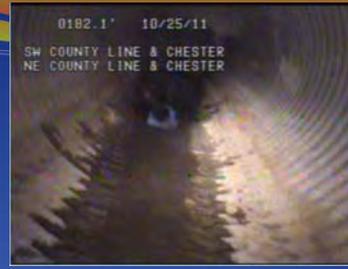
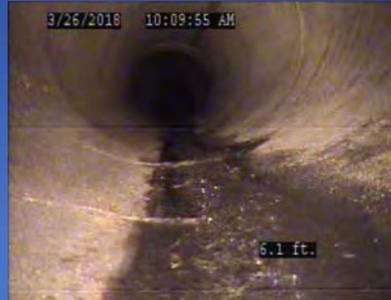
In 2011 sinkholes began to form along the 60" CMP alignment running under County Line Road at Chester St. Pipe inspection revealed several holes along the invert of the CMP.

Pipe re-inspected in March of 2018, liner was observed to still be in excellent condition after ~6 years of service.

SEMSWA partnered with the City of Lone Tree to install CIPP within the CMP. Total project cost ~\$160,000. Completed over the course of a week (October, 2011) with minimal disruption to traffic. Direct replacement estimated at ~\$350,000.

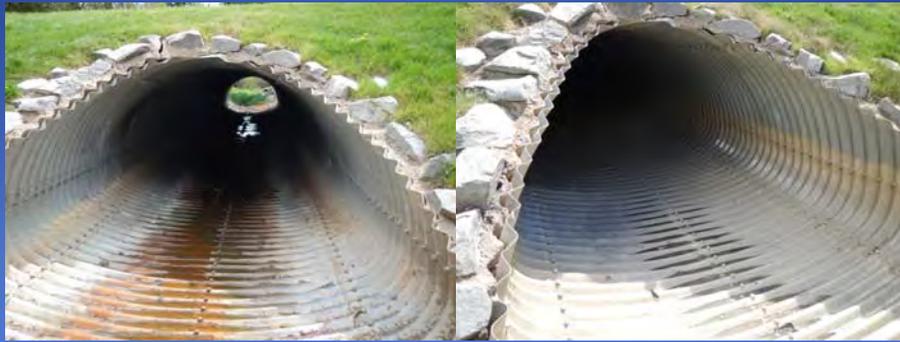
Site visit in March 2018 confirmed the CMP and the liner is still in good condition.

2014 SEMSWA used a Polyurethane Spray on product to line and protect the bottom of an 80" x 132" arch CMP crossing for the Phillips tributary at E Phillips Pl.

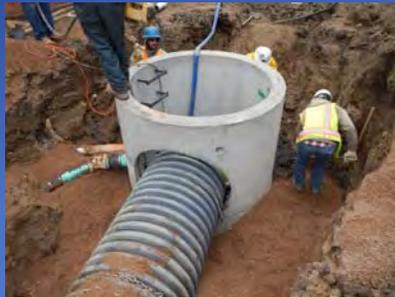
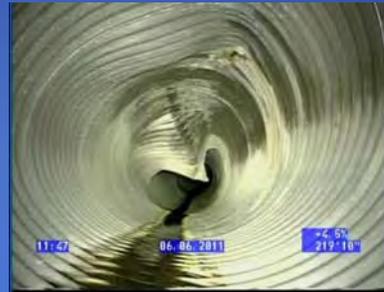
2015 SEMSWA replaced a severely damaged and corroded 30" storm sewer within a green belt near E Mineral Drive and S Vincennes Way.

Pipe deformation eliminated the option of relining the CMP. SEMSWA utilized High Density Polyethylene (HDPE) storm sewer in lieu of the traditional Reinforced Concrete Pipe (RCP). Lower risk site provided a good location for a case study of HDPE and it's performance over time.

Replaced ~ 350 lf of CMP, project cost ~ \$75,000.00.

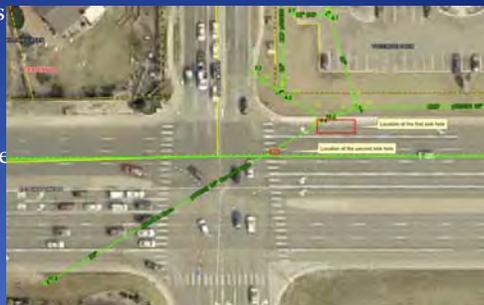
2015 – Higher than usual precipitation led to the formation of several sinkholes including 2 on County Line Rd. and Yosemite St. along the alignment of a 36" CMP. Emergency repairs included flash filling the sink holes and relining the 36" CMP running under County Line Rd.

310 LF 36" CIPP - \$64,000
