Engineering and Construction Division

SEMSWA's Pipe Rehabilitation Program

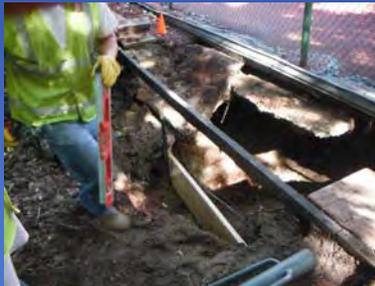
As of June, 2012 SEMSWA had identified 41,109 linear feet of CMP within its service area, of which nearly 10,000 linear feet was classified as being in “Poor” or “Critical” Condition.

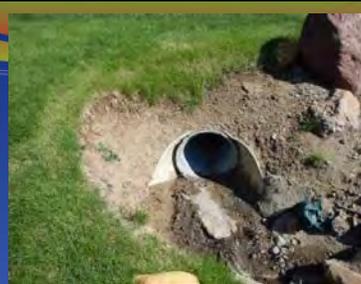
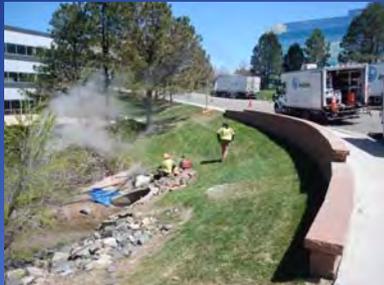
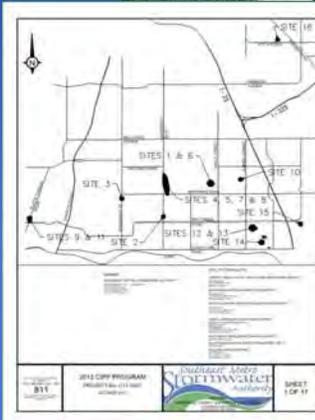
2013 SEMSWA lined ~4,200 LF of CMPs with CIPP
 22 Sites across SEMSWA's jurisdiction
 Project cost \$770,000.00

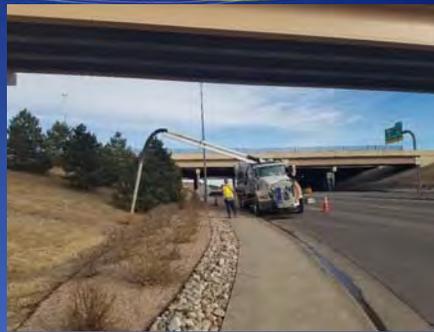
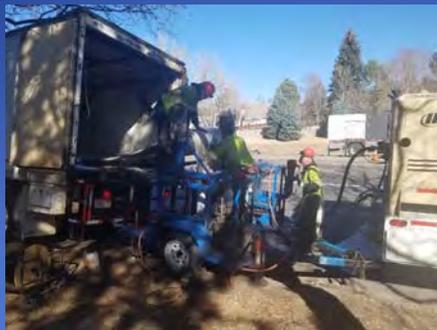
2015/2016 SEMSWA rehabilitated
~3,774 LF of CMPs with CIPP at 15 Sites
across SEMSWA's jurisdiction.
Additionally partnered with Arapahoe
County to line 3 irrigation culverts off
Platte Canyon Road
Project cost ~ \$800,000.00

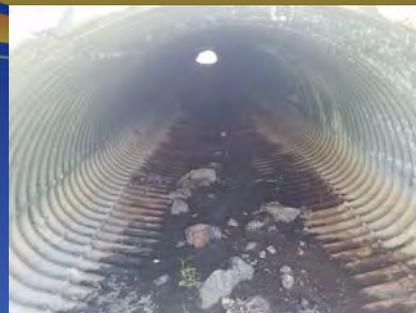
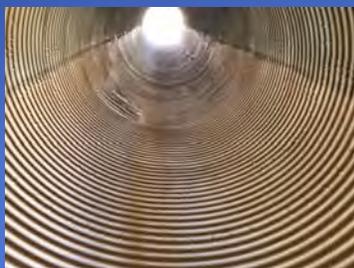
In 2018 SEMSWA plans to line
~3,177 LF of CMPs with CIPPs across 15
Sites.

84" x 132" Arch CMP under Yosemite Rd
to be lined with new type of Carbon Fiber
Reinforced Polymer SIPP – proposed cost
\$117,500. Direct Replacement estimated at
~\$600,000.

Treated Invert of 72" CMP – at E Jamison
Dr. – Cost of \$25,850.00.
