Maintenance & Inspection Division

March 2018 Update

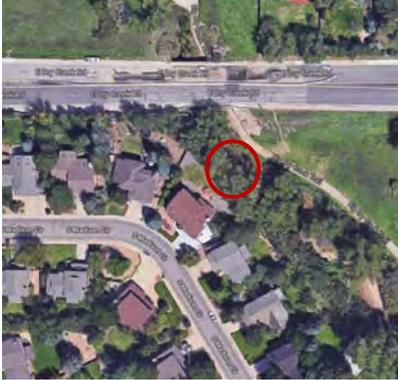
Before Big Dry Creek @ Dry Creek Rd. Outfall Repair

This section shows the 'Before' state of the project. It includes an aerial map with a red circle indicating the location at the intersection of Big Dry Creek and Dry Creek Rd. Two photographs show the initial site conditions: a yellow excavator clearing a steep, wooded embankment, and a concrete pipe being prepared for installation in a trench, with orange safety netting visible.
